DEPARTMENT OF TRANSPORTATION**DIVISION OF ENGINEERING SERVICES**

Contract #: 04-0120F4Cty: SF/ALA Rte: 80 PM: 13.2/13.9File #: 69.28**WELDING INSPECTION REPORT****Resident Engineer:** Siegenthaler, Peter**Address:** 333 Burma Road**City:** Oakland, CA 94607**Report No:** WIR-017500**Date Inspected:** 29-Sep-2010**Project Name:** SAS Superstructure**OSM Arrival Time:** 700**Prime Contractor:** American Bridge/Fluor Enterprises, a JV**OSM Departure Time:** 1900**Contractor:** Zhenhua Port Machinery Company, Ltd (ZPMC), Changxing Island **Location:** Shanghai, China

Heavy Dock#Tower Trial assembly

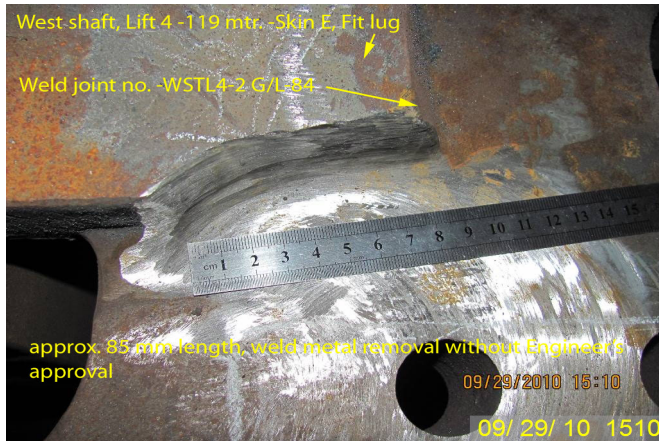
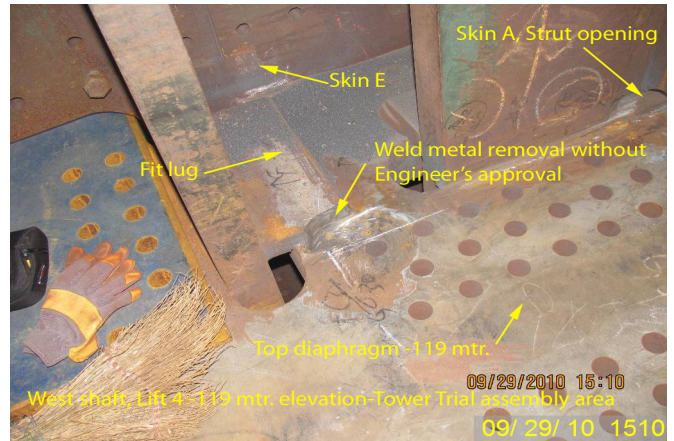
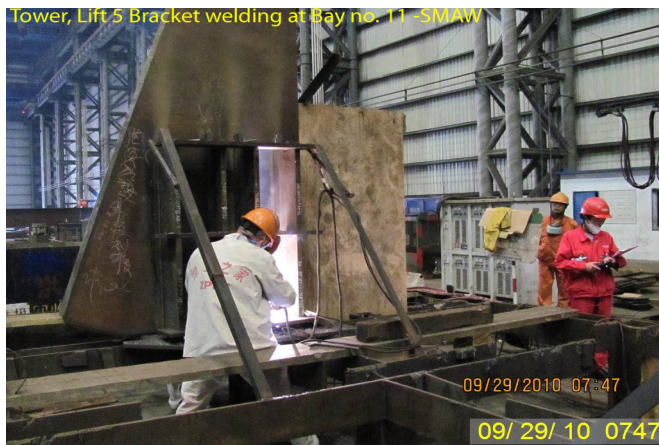
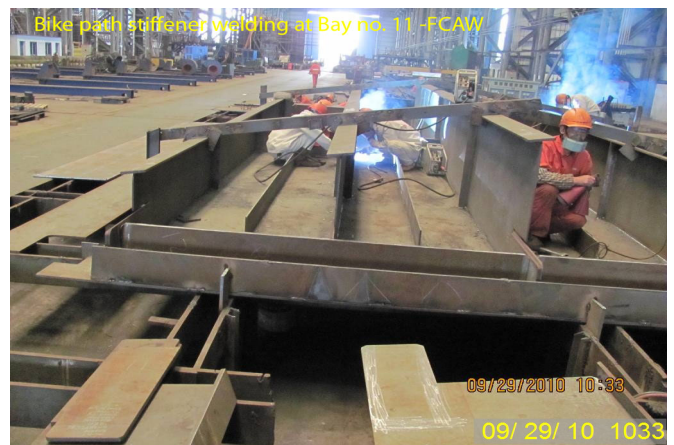
- Approx. 85 mm length, 25 mm width, Weld metal Removal observed in Skin E, Fit lug weld without Engineer's approval.
- The Fit lug found in West Tower, Lift 4- 119 mtr. top diaphragm.
- The Weld joint no. of the fit lug weld found to be WSTL4-2 G/L-84.

AWS D1.5 Section 3.7.5- “ The Engineer shall be notified before improperly fitted and welded members are cut apart.”

This QA notified ZPMC QC identified as Mr. Zhao Chen Sun and ABF inspector identified as Mr. Bi De Wei of the above issue and that an incident report will be generated.
